Subject: Bulk oil remounting kit

Date: Oct 22, 2024

Model Affected: LVE 304 (LOV series 300 four vat units only)

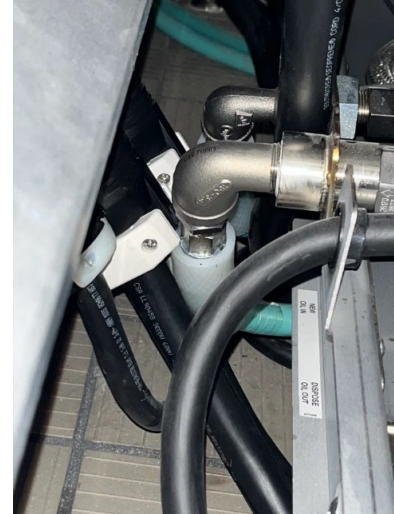
In certain installations, the bulk oil (RTI) connections at the rear of LVE-304 fryers built before LC2410145 may interfere with power cord connections (see image at right). This prevents the fryer from pushing back against the wall and allows 2-3 inches of the fryer to stick out past the front of the hood enclosure.

To resolve this issue, kit **140938** is now available which repositions the bulk oil (RTI) connections to avoid power cords at the rear of the fryer. Instructions are included with this kit and available on service.hennypennyhelp.com: [Bulk Oil Retrofit Move](#)

When starting up any LVE 304 (four vat fryers) built before LC2410145, **ensure you have kit 140938 on hand ready to install at start up.** In the event this kit is needed, file a warranty claim for the kit and your labor (up to 1 hr.) to install. Since this should be done at start up, travel time will not be accepted as part of this warranty claim.

IMPORTANT: Kit 140938 should only be installed if there is interference between the power cords and the bulk oil connections, which prevents the fryer from being pushed back, all the way under the hood.
